Nature Line CT Phantom – Pelvis with Femoral Neck Fracture

Pelvis Phantom with Femoral Neck Fracture

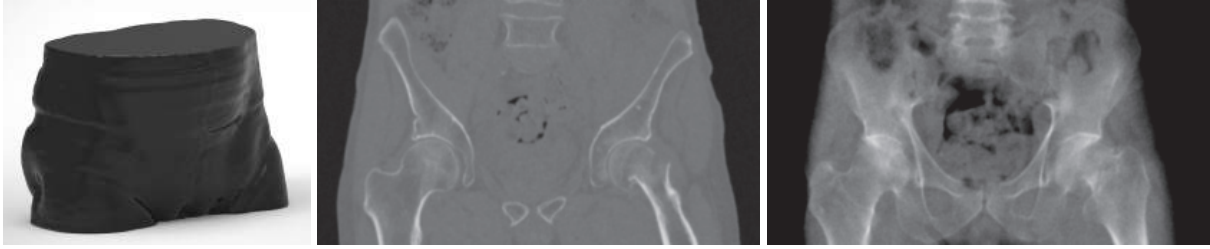
Size	Approx. 26.7 x 16.7 x 15.8 cm
Weight	Approx. 5 kg

Pelvis phantom with femoral neck fracture on the left side.
 Attenuation values are calibrated to be equivalent to human tissue at 120 kVp CT imaging.
 Calibration to other spectrum energies (e.g., 100 kVp CT imaging) is possible upon request.
