FERRALERT® ENCOMPASS LE

The Most Comprehensive and Reliable MRI Safety Solution

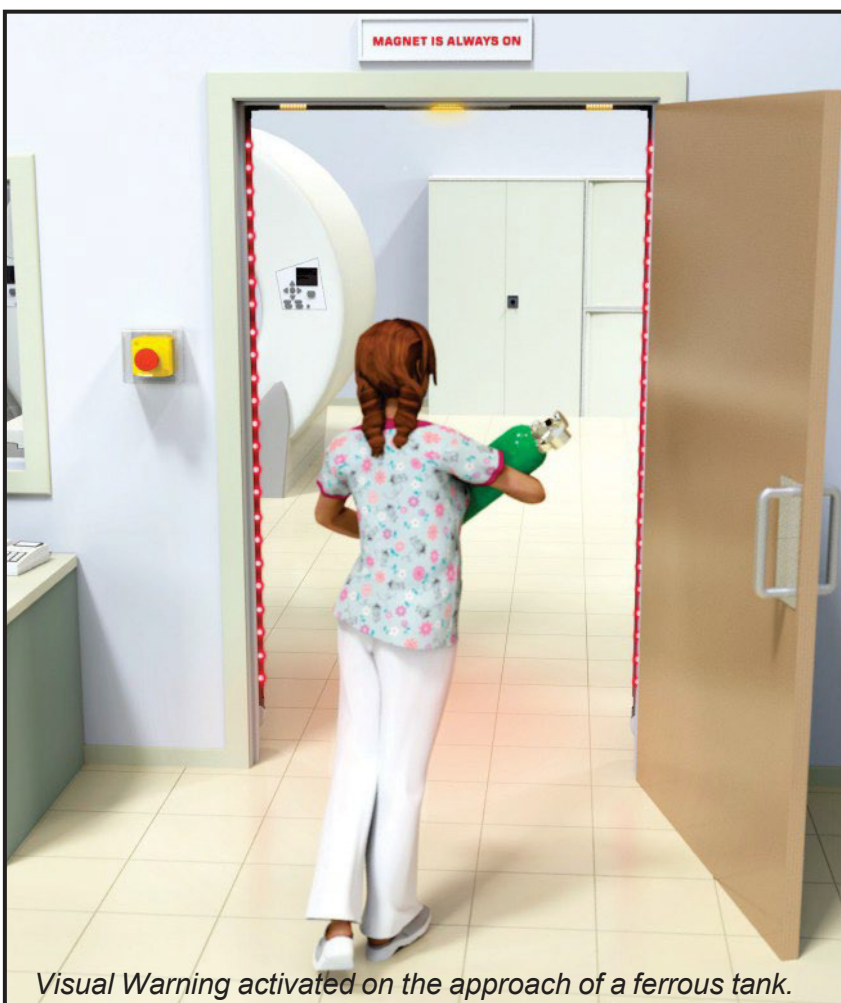
FERRALERT® HALO^{II} Plus X^B

FerrAlert® provides the most reliable detection and prevention of ferromagnetic threats from entering the MRI room (Zone IV). FerrAlert® detectors are recognized to be the most accurate ferromagnetic detectors for MRI, due to their exclusive object location-specific feature.

- Intelligent Pre-Warning on approach WELL OUTSIDE the magnet room
- Instantly PINPOINTS LOCATION of the ferromagnetic threat
- NO INTIMATE CONTACT required
- Alarms are visible from INSIDE and OUTSIDE the magnet room
- REDUCES ALARM FATIGUE by sensing direction of traffic
 - ✓ No Alarm on Door
 - ✓ No Alarm on Exit
 - ✓ No Alarm on Cross Traffic

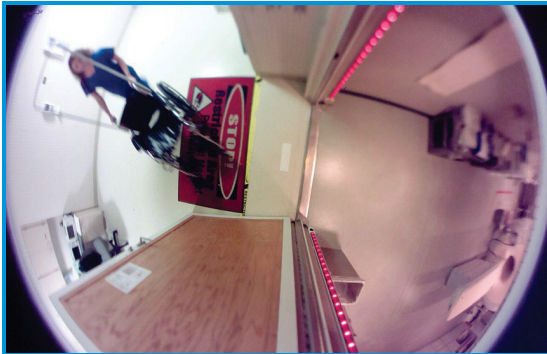
Visual Advance Pre-warning:

All 48 red alarm lights of FerrAlert® HALO II PLUS XB are activated on the approach of a ferromagnetic wheelchair WELL OUTSIDE the scanner room. No Audio alarm sounds at this time.

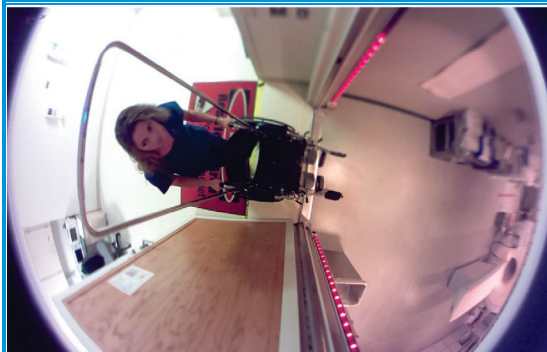
Audio alarm and F.I.L.M. are activated:

When the Photoelectric sensor of the FerrAlert® HALO II PLUS XB is crossed, the F.I.L.M. stores the images that lead up to the activation. F.I.L.M. continues to take and store images after the incident occurs to document actions after the incident.

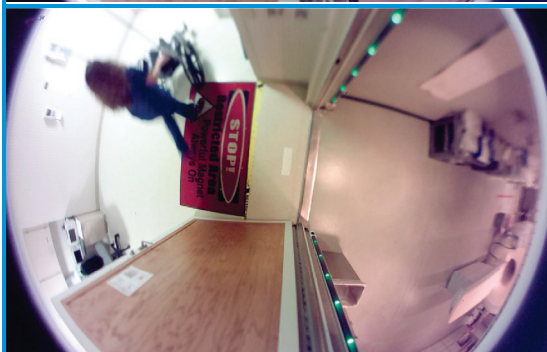
Action taken after incident:

The person did not continue into the scanner room, but instead turned around and left the area. The green READY lights illuminate indicating that there is no approaching ferromagnetic threat.

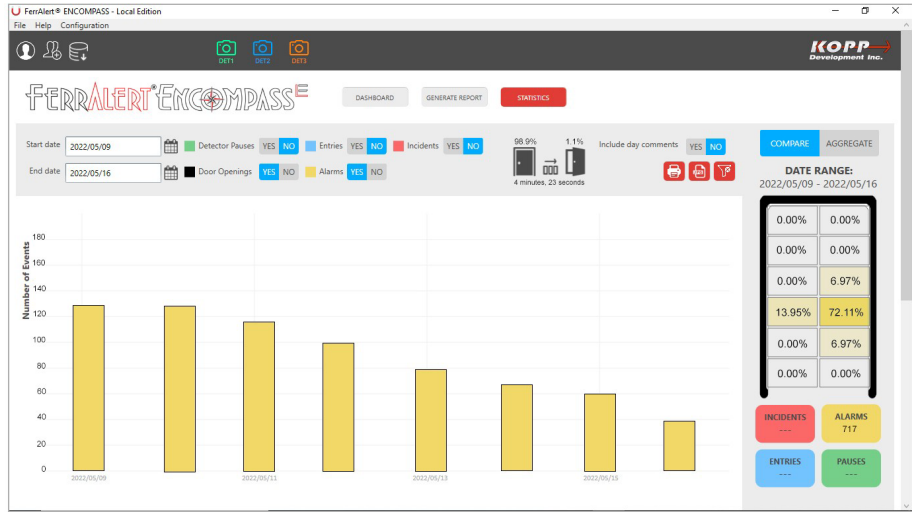
Track Trends

From the **STATISTICS** tab, occurrences are plotted.
